Use Attainability Analysis

WBID 992 Tributary to Labadie Creek

Alliance Water Resources for PWSD #3

Missouri Department of Natural Resources  
Water Protection Program

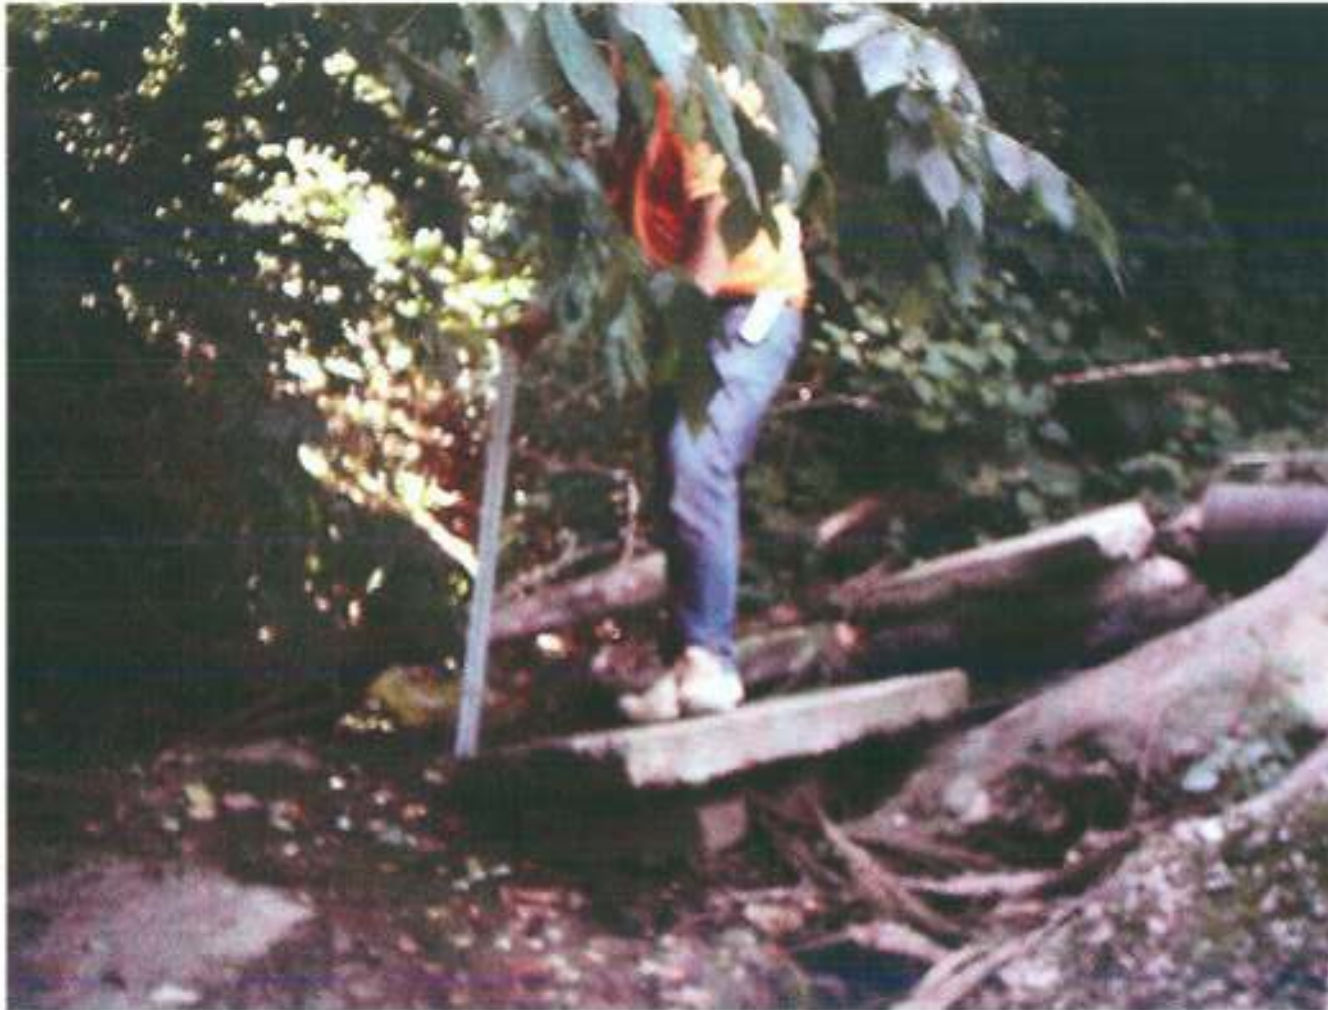
Picture #1

Site 1 (location N 38 29.488', W090 53.752') is a downstream view of the plant discharge into a wet weather tributary of the subject of this UAA. As you can see in Picture 1 the only flow normally is the WWTP effluent.

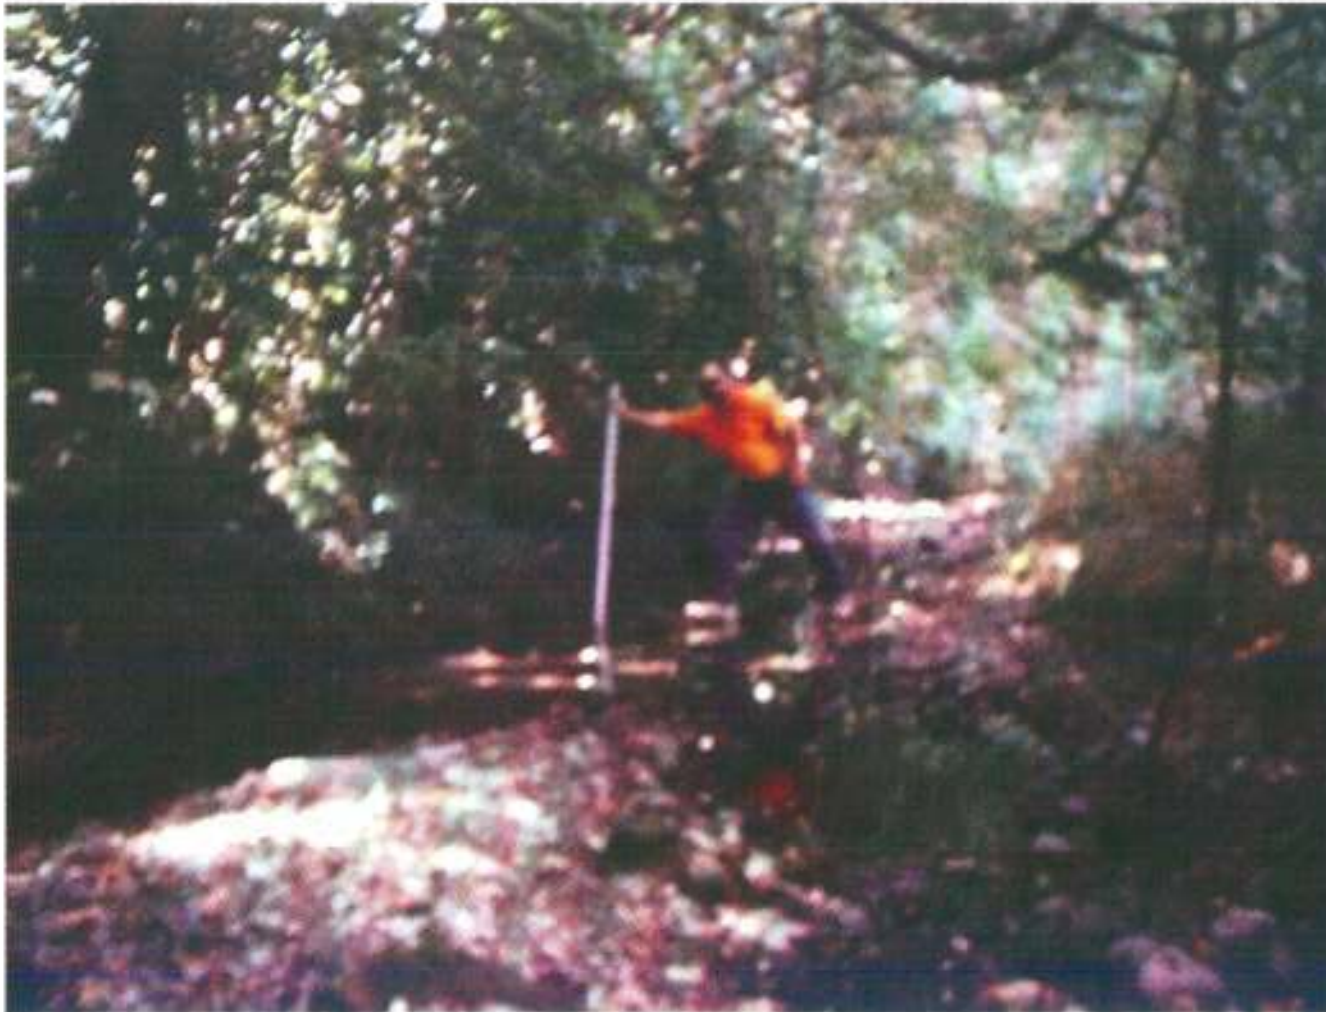
Picture #2- Downstream

Site 2 (location N 38 29.697', W 090 50.042') is located 0.77 stream miles downstream of the WWTP discharge point. Pool depth is 10 inches and flow depth at the riffles was  $\frac{1}{2}$  inch and approximately 6 inches wide. Picture 2 is the downstream view while Pictures 3 & 4 are the upstream views. The bottom of the creel consists of rocks and gravel.

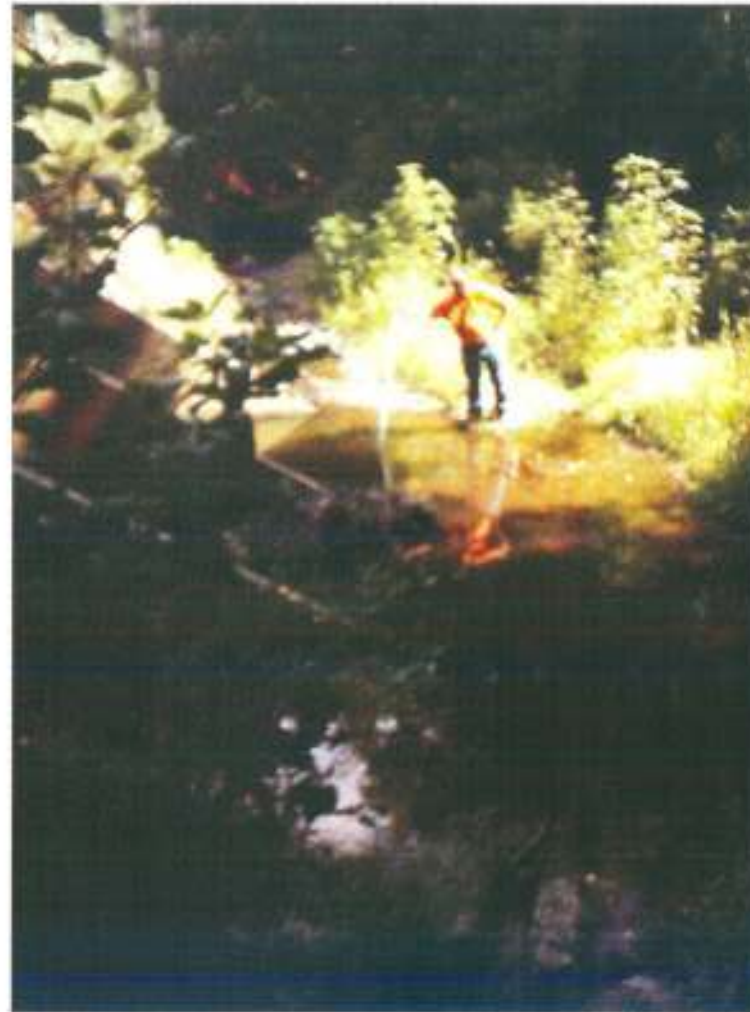
Picture #5

Site 4 (location N 38 30.087', W 090 50.322') is located just downstream of Purina Farms and is the first public access point downstream of the discharge. Site 4 is located where the tributary crosses Highway MM and is 1.34 stream miles downstream of the discharge point. At this location the stream consists of pools on either side of the box culvert crossing MM and rocky riffles. Pool depth was measured as 9 inches. Riffles were approximately 1 inch deep and 2 feet wide. Picture 5 is an upstream view from the southwest side of MM and Picture 6 is a downstream view northeast of MM.

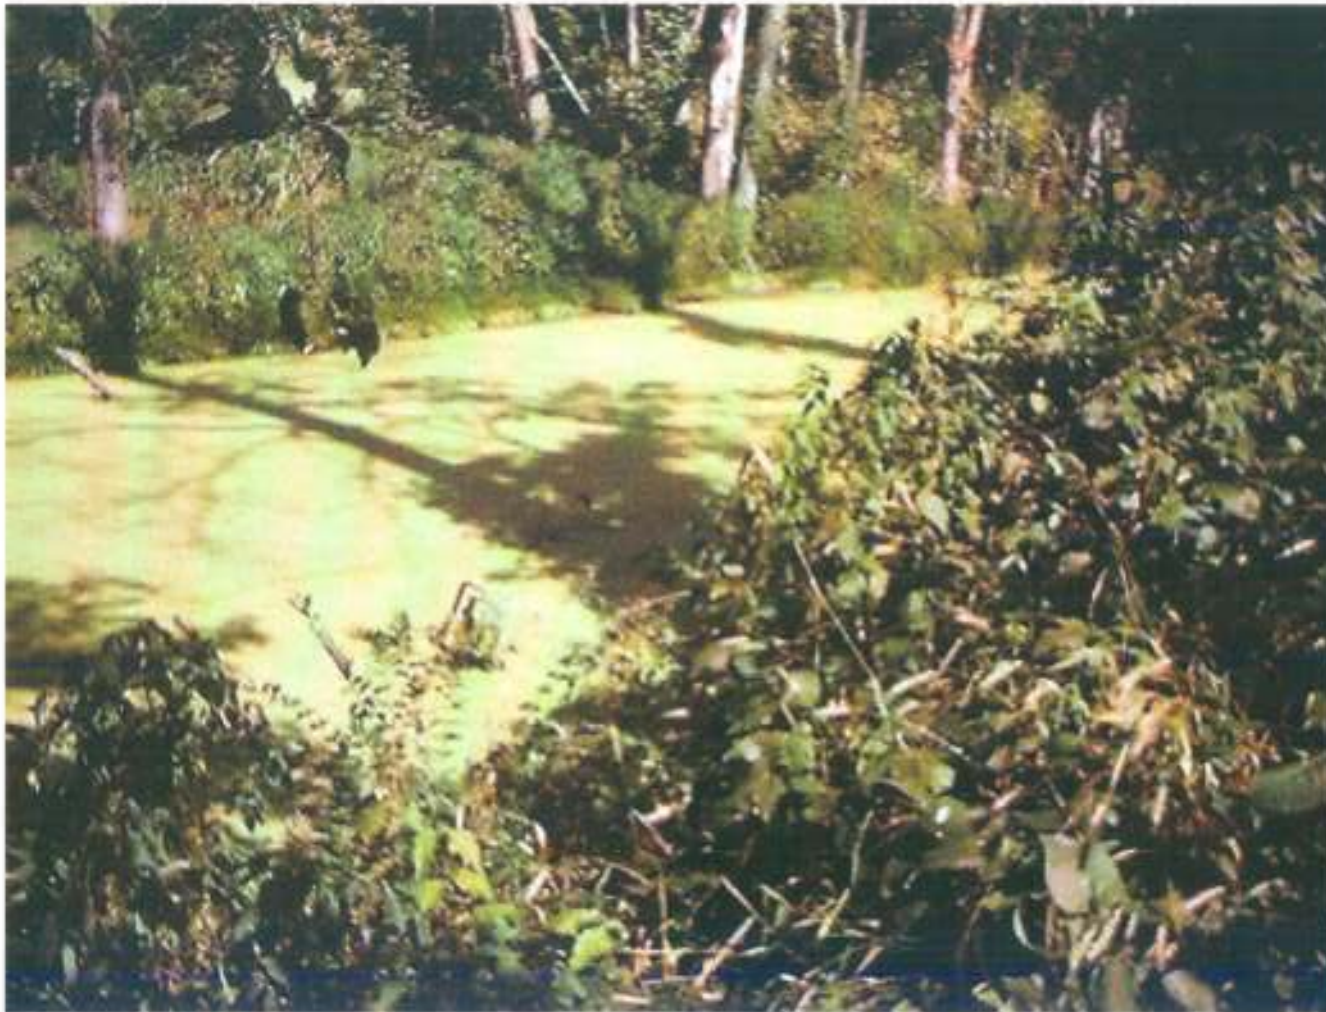
Picture #9

Water was 100% covered by duckweed.

Site 5 (location N 38 30.240', W 090 50.360') is located in Beauty View Acres Subdivision. The only area that had access to the stream was at the discharge for the subdivision's wastewater lagoon. The stream at this location was a pool for the entire width and length of the stream. The pool was entirely covered with duckweed as this is the location because of the discharge for the aerated lagoon. The bottom of the stream was a thick soft mud interspersed with numerous limbs from the trees that lined both banks. The depth of the pool measured between 1 and 2 feet deep. The thickness of the mud was approximately 6 to 8 inches deep. Picture 9 depicts the downstream view while picture 10 is the upstream view. Picture 11 is of the area where the lagoon discharge enters the stream.

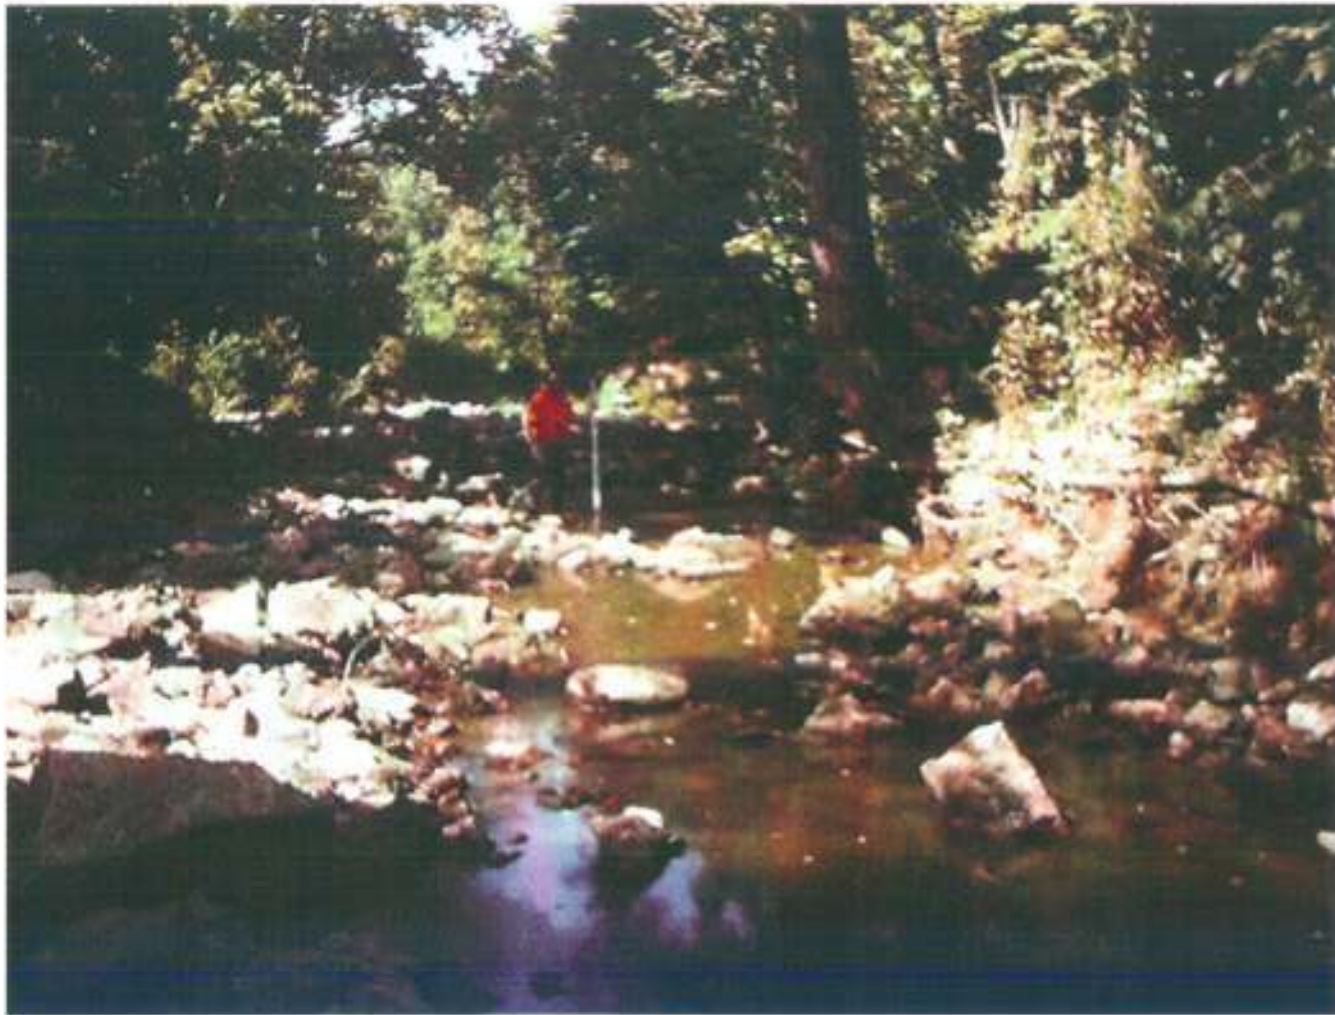
Picture #7

Missouri WBID #: 1694		Site Location Description: Intersection of Hwy MM, MO-Pac RR, and Labadie Creek (Site 6)	
Site GPS Coordinates: N.38°31.217' W.090°50.895'			
Date & Time: 7/8/05		Facility Name: Pine Lake Estates Subdivision	
Personnel: Richard Tuttle & Bob Hathcock		Permit Number: MO-0111554	
Current Weather Conditions: Sunny & Hot		Weather Conditions for Past 7 days: Sunny & Hot	
Photo Ids: Upstream: #8	Downstream: #7	Other:
